# Revista de la Universidad del Zulia

**Enero - Abril 2024**

## Environmental Consequences of the Explosion of the Kahovsky Hydroelectric Plant on Biodiversity

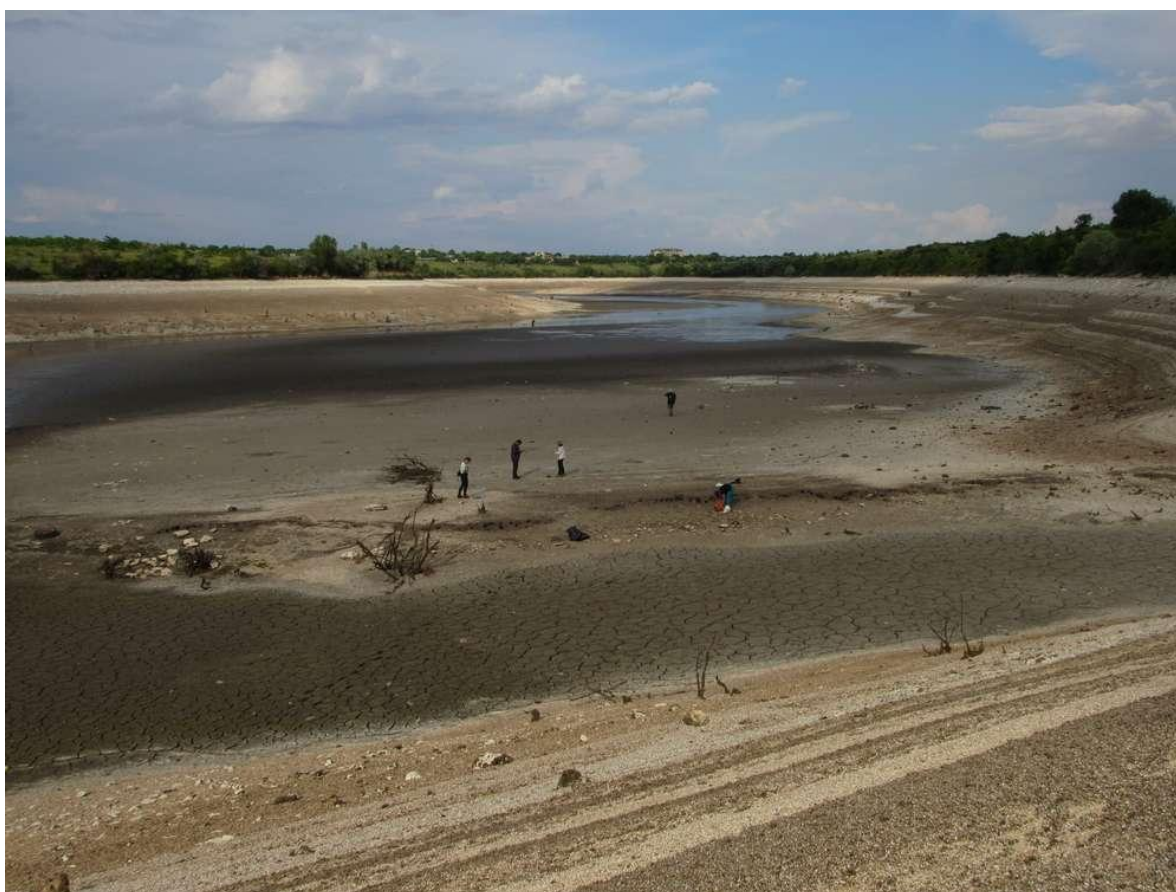
On June 6, 2023, Russian troops blew up the dam of the Kakhovka hydroelectric power station. As of June 14, 2023, about 72% of the water volume, or 14,395 km<sup>3</sup>, has been lost from the Kakhov reservoir (Figure 1) (Feshchenko, 2023).

Figure 1. Drained sections of the Kakhov reservoir, as a result of the dam explosion of the Kakhov hydroelectric plant
